Granamore Commonage

2019 Ecological Survey

Final Report

16th March 2020

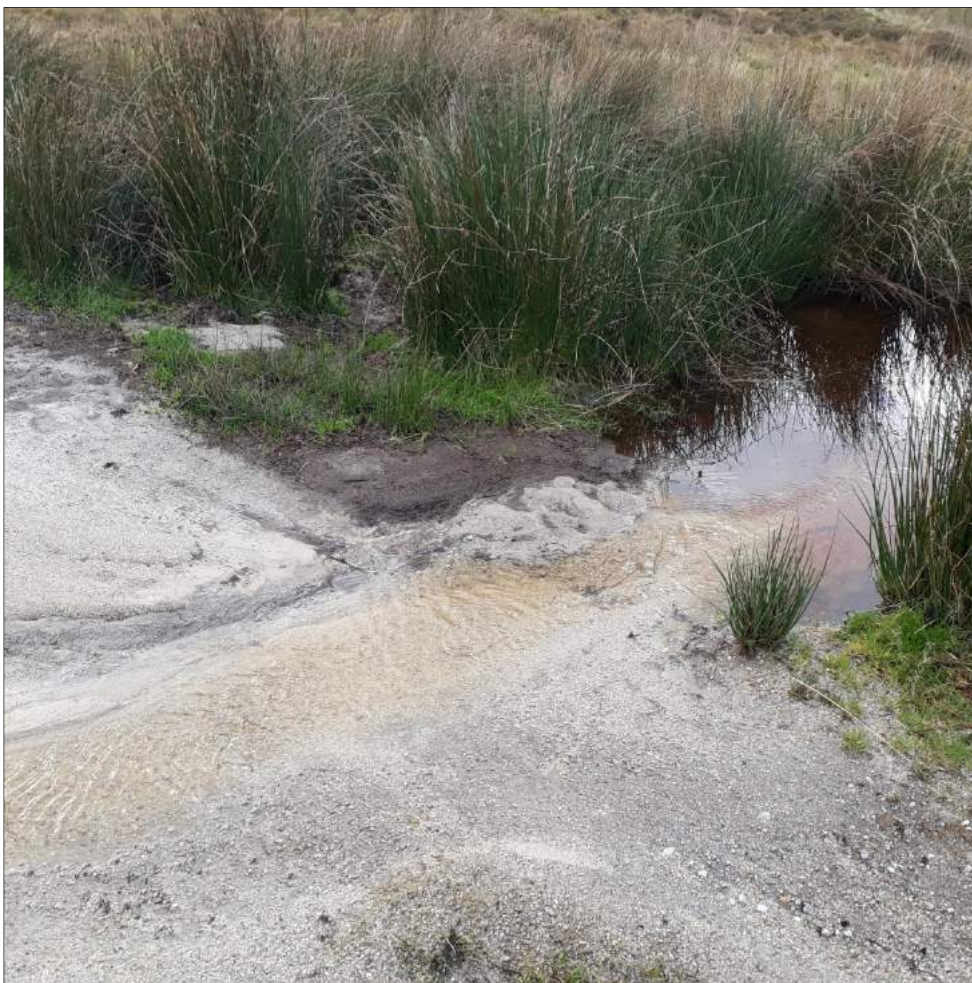
Initial works have been done on the roadway to divert the water from the track in consultation with National Parks and Wildlife Service (NPWS). This work has been done very sensitively and has been well executed.

Plate 1. Recently cleared shores allowing the water to escape off the track.

On the day of my visit there was a considerable amount of surface water continuing to come down the track and I wondered if the installation of a series of water bars along the track – particularly at the shores should be implemented.

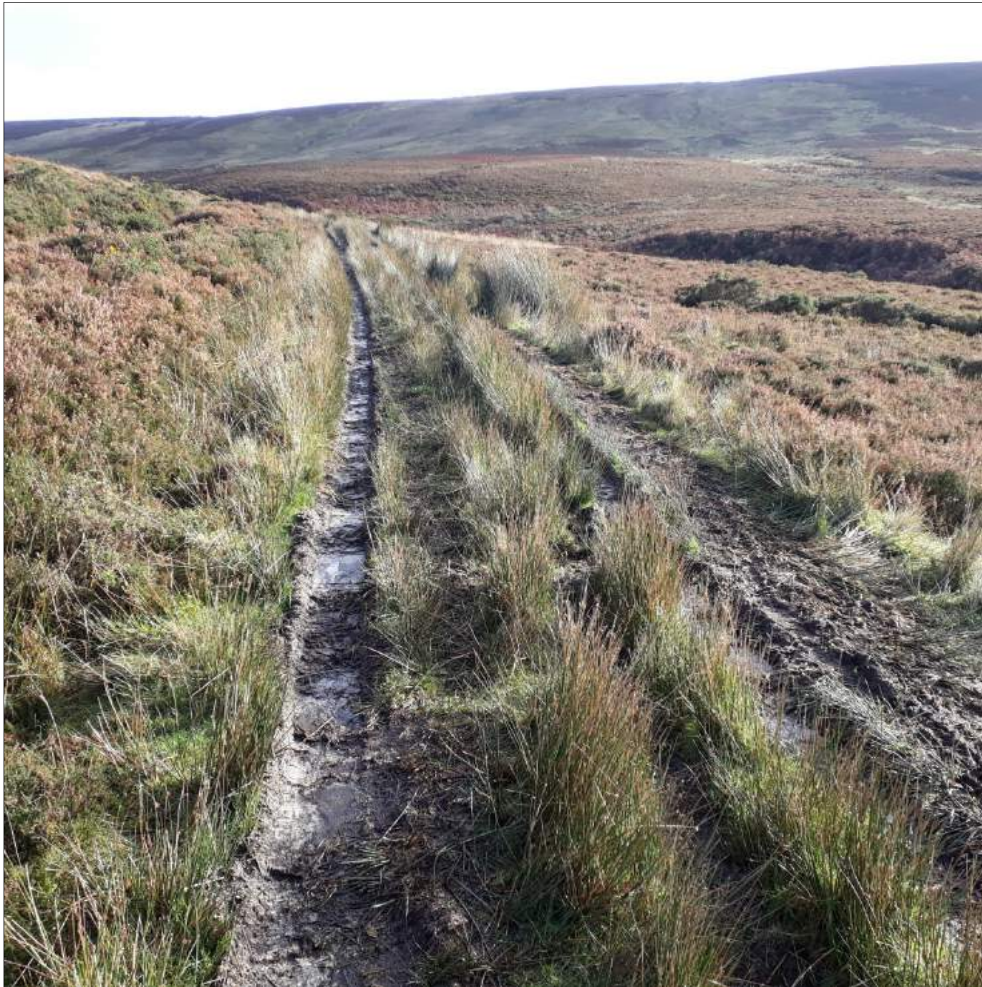
Above the old borrow pit (in Area 20) the track is very wet and dominated by rushes particularly in the centre of the track. There is very deep rutting of the track here, which is actually creating a channel for water and exacerbating the situation downslope on the track.

Plate 2. Tyre tracks have created deep channels for water to flow down on the track above the old borrow pit.

It is understood that the farmers are waiting for the roadway to dry out before they do anymore, and all works will be in consultation with NPWS (they prefer not grading off the roadway if possible following, some investigations by themselves). On the area above the borrow pit, there is no

foundation under most of this and any work needs to be carefully planned and Ann Fitzpatrick, NPWS is working with the farmers on this.

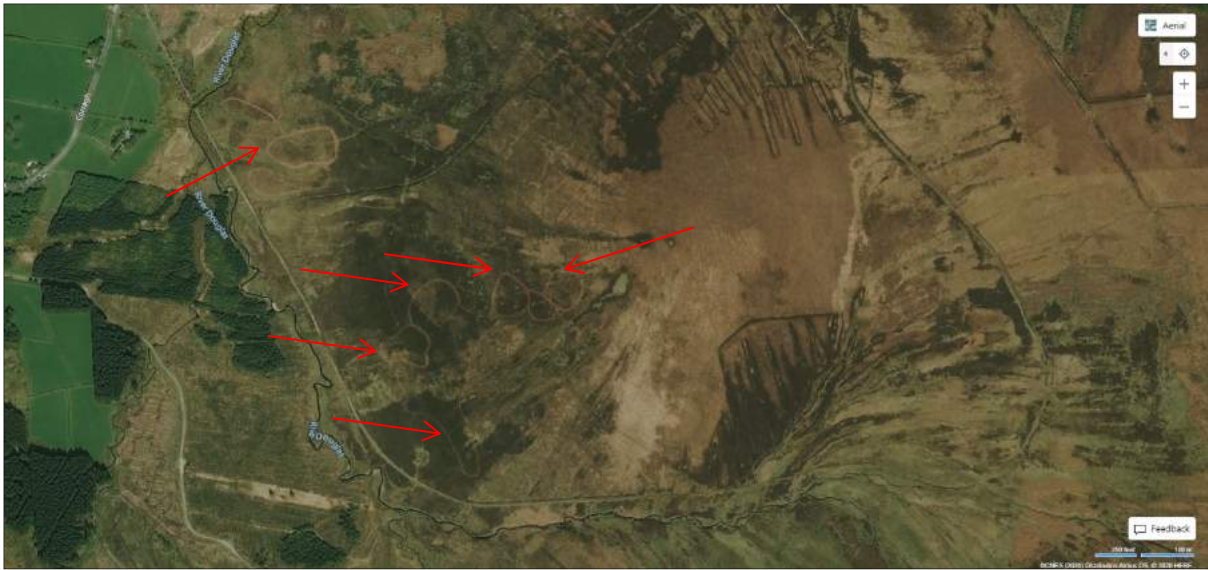
It appeared as if a number of firebreaks for controlled burning had been created on Granamore commonage as can be seen in the Bing Maps imagery of the commonage as presented on **Figure 1** below. These were created in Area 10 and Area 20 on the slopes of the hillside using a flail behind a tractor but this cutting activity was not intended to be used as firebreaks.

There were no actual firebreaks cut on Granamore. The plan was for some cutting/mulching of vegetation in area 20, particularly areas dominated by gorse. The tractor and mulcher was not able to work in the very rough and stony areas, so he just cut in the areas where he could. The contractor just cut in large circles like he did on the other sites, even though he was supposed to cut small isolated areas (no one from the project team was there to supervise him on the day). He also did some cutting in area 10 as the farmers asked him to, but these are not firebreaks.

Figure 1. Firebreaks cut on Granamore Commonage (Bing Maps).

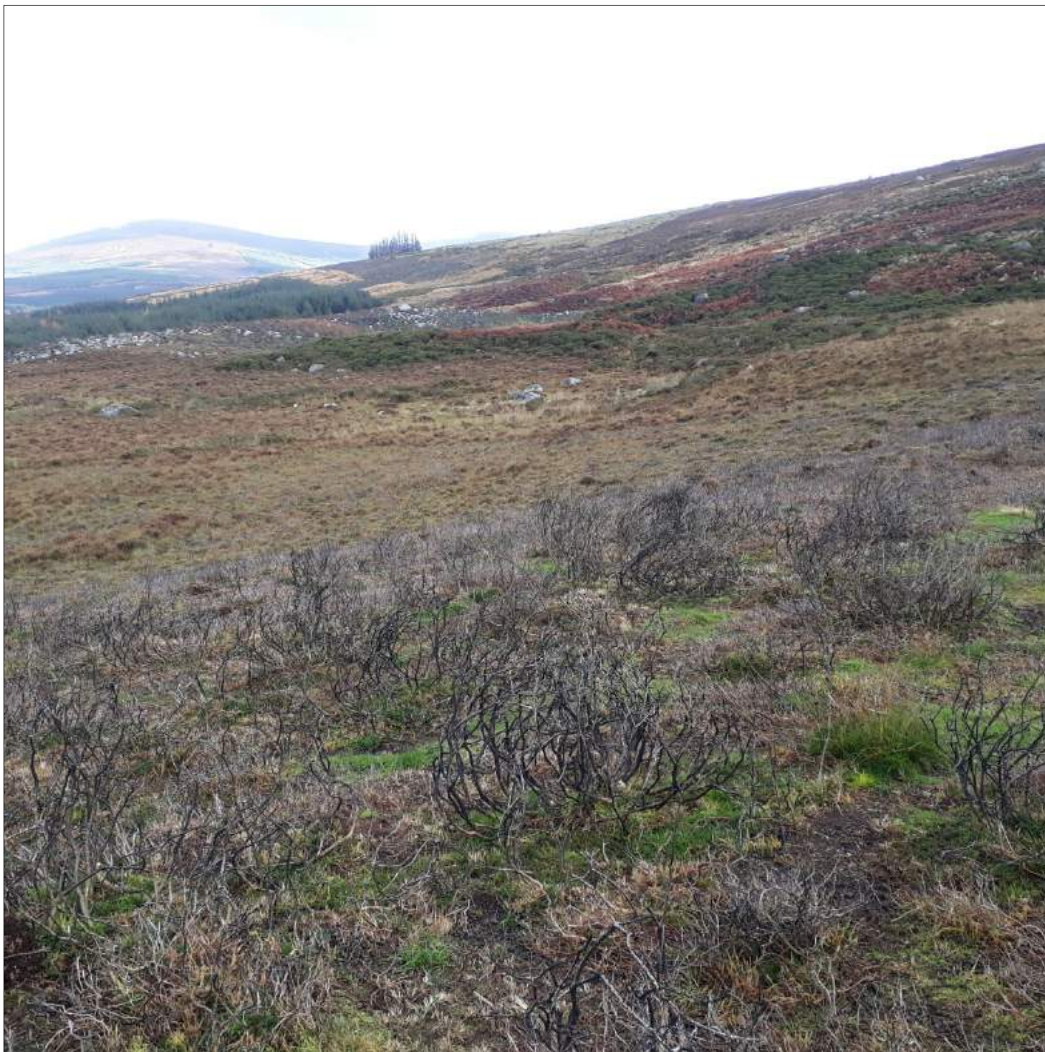
Plate 3. Burnt gorse on the knoll in Area 10.

Sheep are congregating in this area post burning with extensive dunging and grazing pressure on the grasses underneath. This has resulted in areas of bare soil and poaching. The sheep need to be shepherded regularly out of this area to reduce browsing pressure on same. Patches of heath rush

(*Juncus squarrosus*) are present and if browsing pressure remains too high this species will begin to dominate as it is unpalatable to sheep.

The burn here would appear to have got out of control and entered the area of adjoining wet heath/blanket bog. Thankfully the ground conditions must have been relatively wet as the *Sphagnum* and other mosses were undamaged and the bryophyte layer is intact but the area is heavily browsed and the sheep need to be moved regularly out of here.

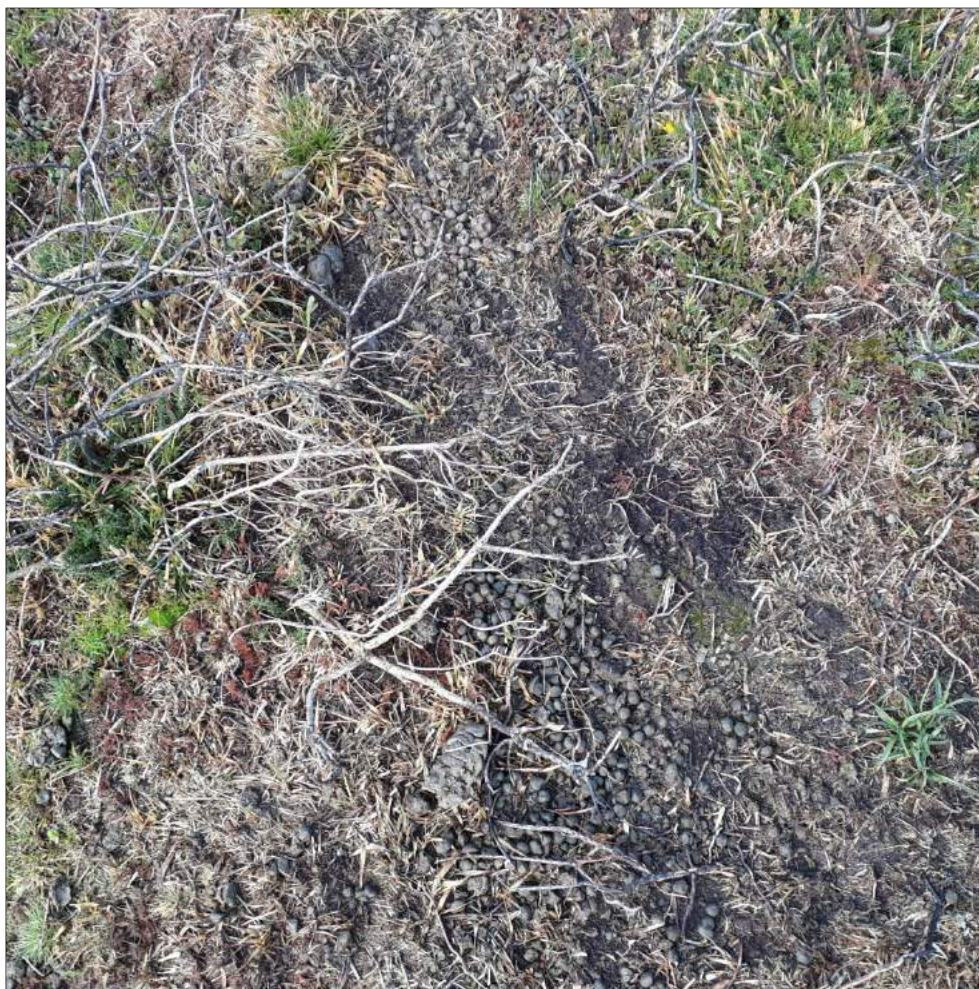
Plate 4. Extensive dunging, bare soil and heavy browsing in the recently burnt area.

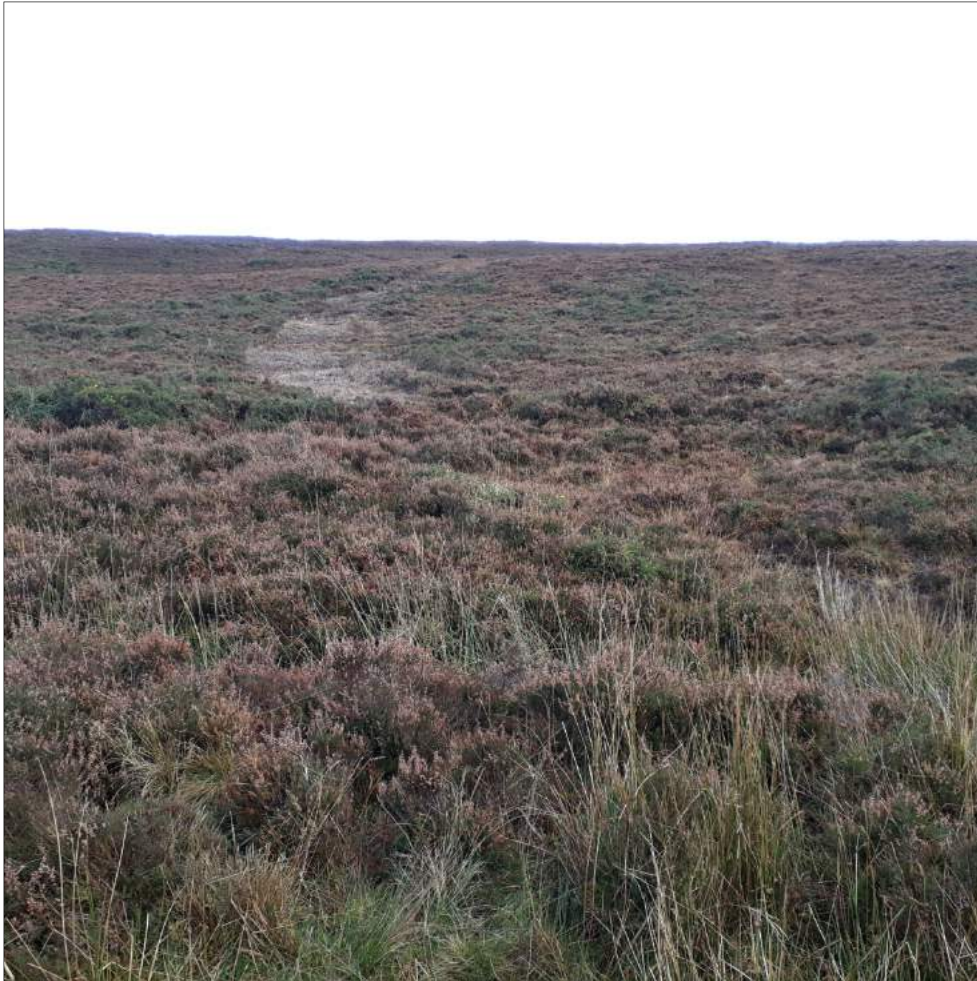
Plate 5. Areas of autumn gorse either side of the flailed track.

In some parts of Area 20 as can be seen in **Plate 5** above the flailed track cuts through some of these patches and these small areas could be burnt or the use of buckets in these areas could be considered to encourage sheep out of the favoured areas and to reduce the vigour of the autumn gorse. Small areas within them could also be manually cut with brush cutters if the ground is unsuitable for a machine to work in.

It would be advisable that if any burning is planned for 2020 it is limited to very small patches within the areas prepared in 2019 that actually require management in Area 20 and that additional areas in Areas 23 and 24 are prepared and either flailed/subject to controlled burning to encourage sheep movement across the northern portion of the commonage.

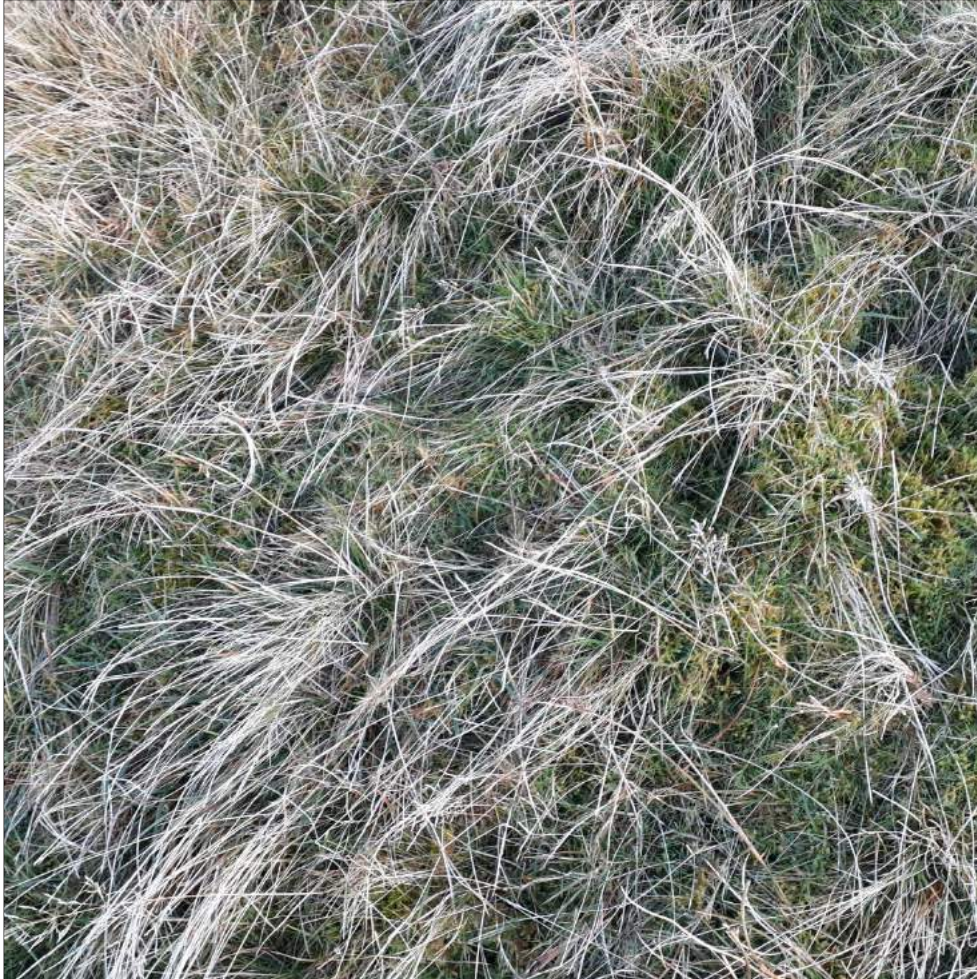
The condition of the acid grassland on the slopes in Area 16 was further examined. These are actually in poorer condition than had been previously thought/initially assessed. In many areas the grass has been all but browsed out with the sward dominated by mosses or in other instances by dense mat grass (*Nardus stricta*) which is unpalatable to sheep. Additional surveys conducted during the vegetation growing season will further examine these areas. The ongoing shepherding and movement of stock off the upper portions of the commonage above the track on the Round Hill must be implemented.

Plate 6. Mat grass dominating the sward.

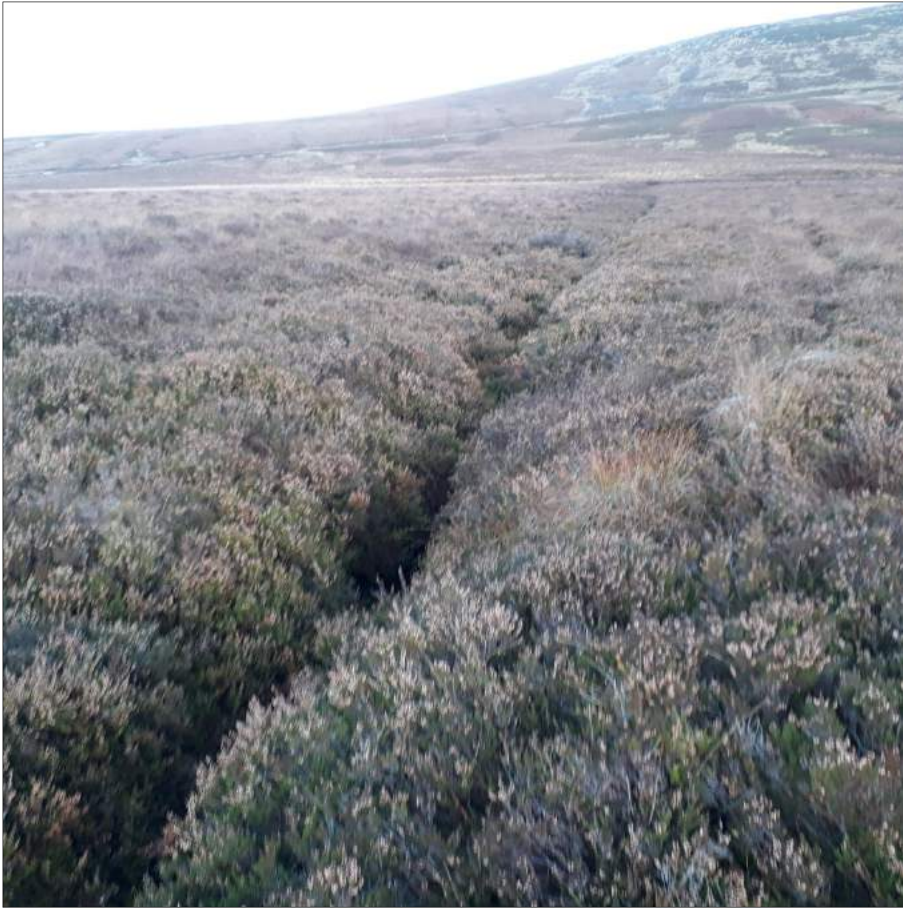
Plate 7. Drain along northern edge of Area 19 awaits blocking.

Drain blocking on the commonage will be completed in 2020.

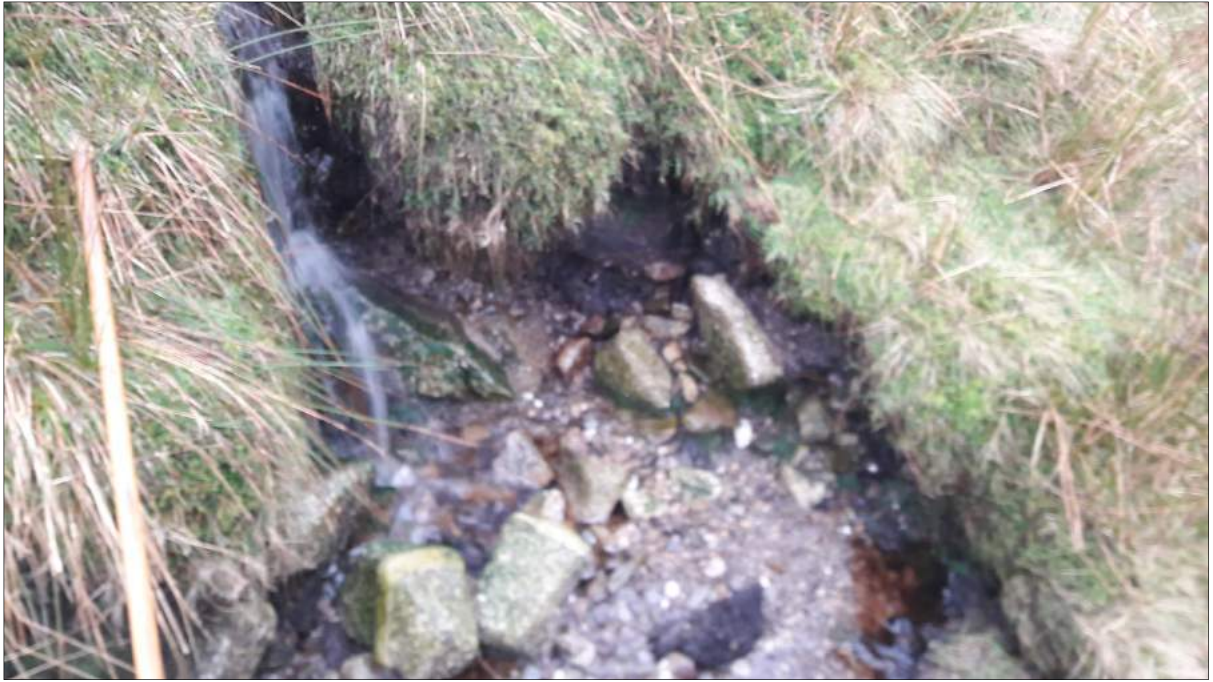
River:	Code:	Date:	Sample Taken By:
Douglas River	IE_EA_09D020200	19/02/2019	Faith Wilson
Sample Number:	Location:	Stream Order:	Grid Reference:
GR1	Headwater stream of Douglas River in Granamore commonage – upstream of forestry	1 st order	S 98976 97975
Velocity:	Clarity:	Colour:	Discharge:
Torrential	Very clear	None	Flood
Fast	Clear	Slight	Normal
Moderate	Slightly turbid	Moderate	Low
Slow	Highly turbid	High	Very low
Very Slow			Dry
			Recent flood
Modifications: Y	Dominant Types:	Slope:	Geology:
Canalised	Bedrock	Low	Calcareous
Widened	Boulder (>128mm)	Medium	Siliceous
Bank erosion - localised	Cobble (32 - 128mm)	High	Mixed
Arterial drainage	Gravel (8 - 32mm)	Very high	
	Fine gravel (2 - 8mm)		
	Sand (0.25mm - 2mm)		
	Silt (<0.25mm)		
Substratum Condition:	Substratum:	Degree of Siltation:	Depth of Mud:
Compacted	Stoney bottom	Clean	None
Loose	Muddy bottom	Slight	<1cm - peat
Normal	Mud over stones	Moderate	1-5cm

Heavy	5-10cm
			>10cm
Litter:	Filamentous Algae:	Stream Flow:	Shading:
None	None	Riffle	High
Present	Present	Riffle/ glide	Moderate
Moderate	Moderate	Slow flow	Low
Abundant	Abundant		None
Stock Access:	Sewage Fungus:	Sample Type (Mins):	Main Land Use Adjacent/Upstream:
Yes - from the adjoining commonage	None	Kick sample - 3	Pasture
	Present	Stone washing	Bog
	Moderate	Weed sweep	Forestry
	Abundant		Tillage
			Urban
			Other

Plate 1. Photographic record of sampling location - GR1.

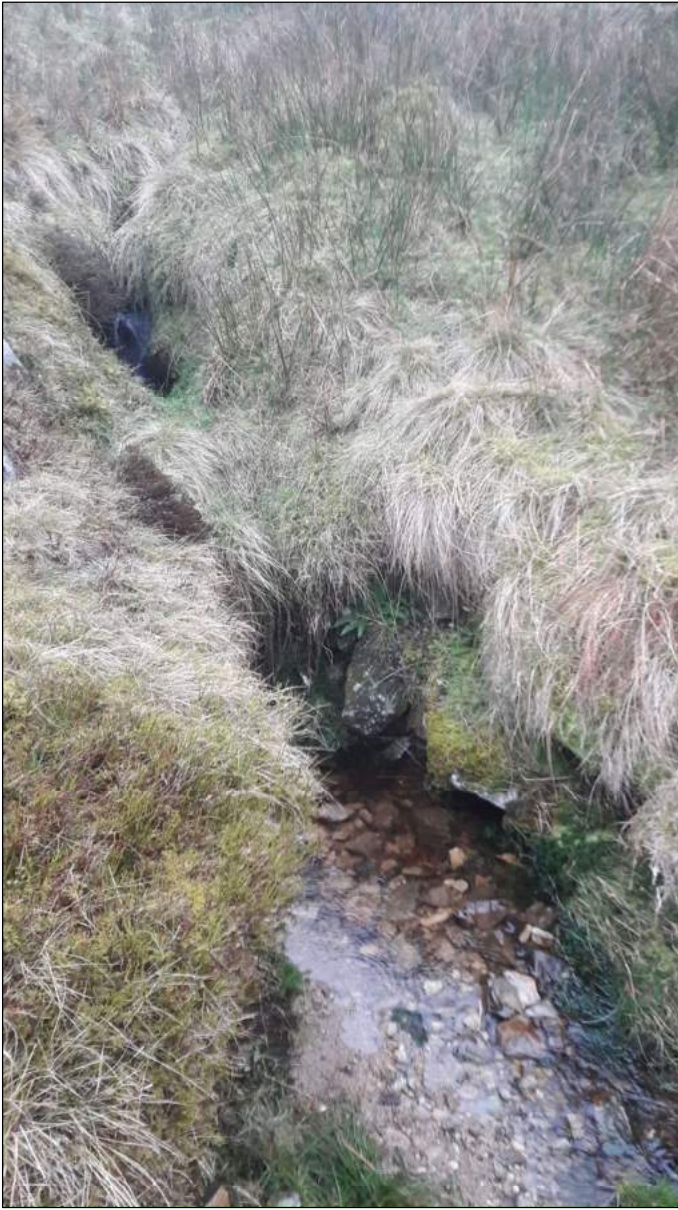
River:	Code:	Date:	Sample Taken By:
Douglas River – unnamed tributary	IE_EA_09D020200	19/02/2019	Faith Wilson
Sample Number:	Location:	Stream Order:	Grid Reference:
GR2	Granamore Commonage -tributary stream of Douglas river	1 st order	S 99345 98133
Velocity:	Clarity:	Colour:	Discharge:
Torrential	Very clear	None	Flood
Fast	Clear	Slight	Normal
Moderate	Slightly turbid	Moderate	Low
Slow	Highly turbid	High	Very low
Very Slow			Dry
			Recent flood
Modifications: Y	Dominant Types:	Slope:	Geology:
Canalised	Bedrock	Low	Calcareous
Widened	Boulder (>128mm)	Medium	Siliceous
Bank erosion - localised	Cobble (32 - 128mm)	High	Mixed
Arterial drainage	Gravel (8 - 32mm)	Very high	
	Fine gravel (2 - 8mm)		
	Sand (0.25mm - 2mm)		
	Silt (<0.25mm)		
Substratum Condition:	Substratum:	Degree of Siltation:	Depth of Mud:
Compacted	Stoney bottom	Clean	None
Loose	Muddy bottom	Slight	<1cm
Normal	Mud over stones	Moderate	1-5cm
		Heavy	5-10cm

>10cm
Litter:	Filamentous Algae:	Stream Flow:	Shading:
None	None	Riffle	High
Present	Present	Riffle/ glide	Moderate
Moderate	Moderate	Slow flow	Low
Abundant	Abundant		None
Stock Access:	Sewage Fungus:	Sample Type (Mins):	Main Land Use Adjacent/Upstream:
Yes - from the adjoining commonage	None	Kick sample - 3	Pasture
	Present	Stone washing	Bog
	Moderate	Weed sweep	Forestry
	Abundant		Tillage
			Urban
			Other

Plate 1. Photographic record of sampling location - GR2.

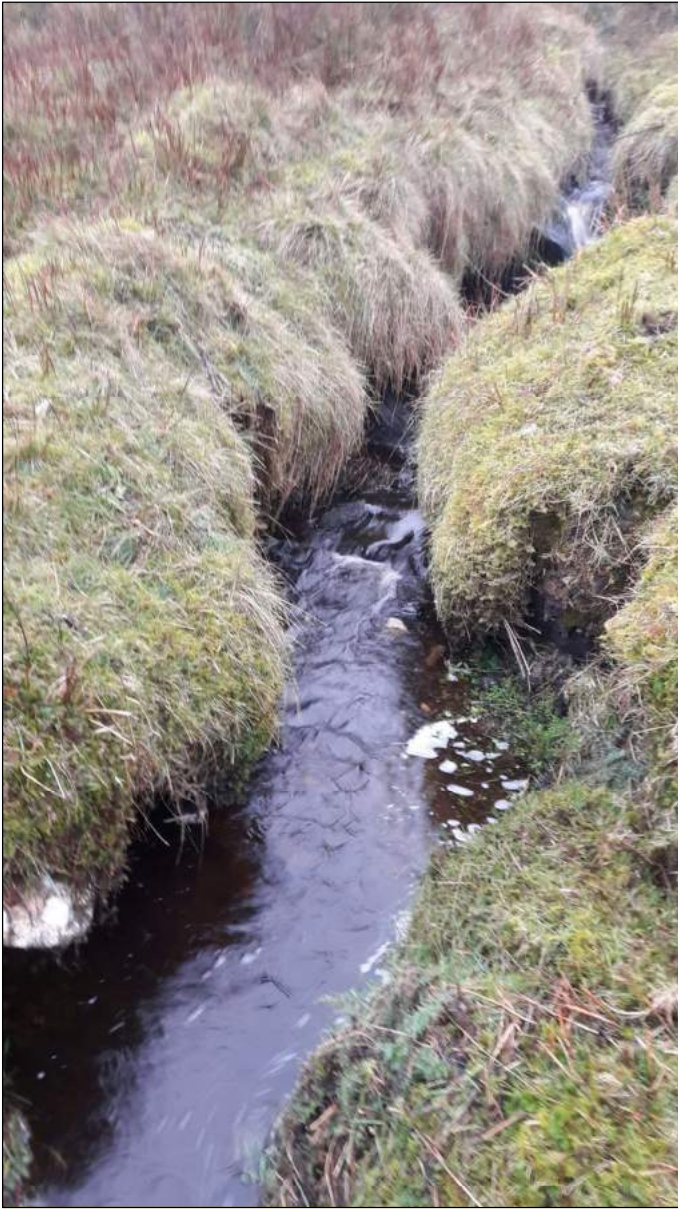
River:	Code:	Date:	Sample Taken By:
Douglas River - unnamed	IE_EA_09D020200	19/02/2019	Faith Wilson
Sample Number:	Location:	Stream Order:	Grid Reference:
GR3	Granamore Commonage - tributary stream of Douglas river	1 st order	S 99347 98741
Velocity:	Clarity:	Colour:	Discharge:
Torrential	Very clear	None	Flood
Fast	Clear	Slight	Normal
Moderate	Slightly turbid	Moderate	Low
Slow	Highly turbid	High	Very low
Very Slow			Dry
			Recent flood
Modifications: Y	Dominant Types:	Slope:	Geology:
Canalised	Bedrock	Low	Calcareous
Widened	Boulder (>128mm)	Medium	Siliceous
Bank erosion - localised	Cobble (32 - 128mm)	High	Mixed
Arterial drainage	Gravel (8 - 32mm)	Very high	
	Fine gravel (2 - 8mm)		
	Sand (0.25mm - 2mm)		
	Silt (<0.25mm)		
Substratum Condition:	Substratum:	Degree of Siltation:	Depth of Mud:
Compacted	Stoney bottom	Clean	None
Loose	Muddy bottom	Slight	<1cm
Normal	Mud over stones	Moderate	1-5cm
		Heavy	5-10cm
			>10cm

Litter:	Filamentous Algae:	Stream Flow:	Shading:
None	None	Riffle	High
Present	Present	Riffle/ glide	Moderate
Moderate	Moderate	Slow flow	Low
Abundant	Abundant		None
Stock Access:	Sewage Fungus:	Sample Type (Mins):	Main Land Use Adjacent/Upstream:
Yes - from the adjoining commonage	None	Kick sample - 3	Pasture
	Present	Stone washing	Bog
	Moderate	Weed sweep	Forestry
	Abundant		Tillage
			Urban
			Other - wet grassland/wet heath

Plate 1. Photographic record of sampling location - GR3.

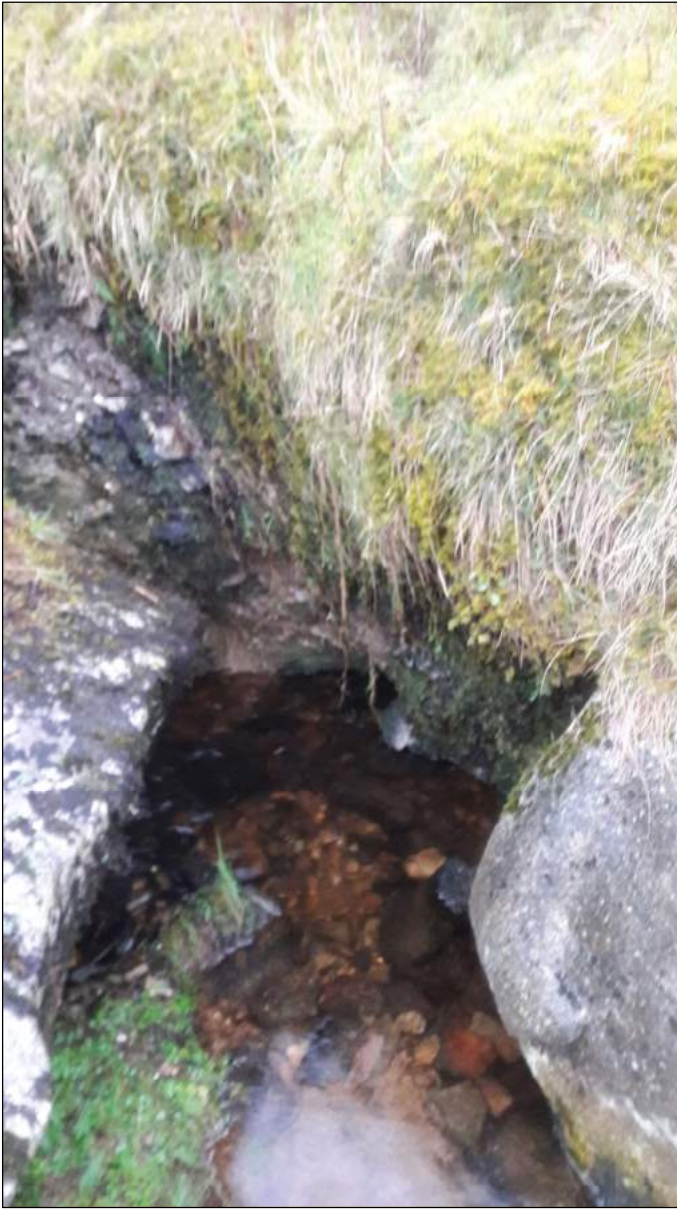
River:	Code:	Date:	Sample Taken By:
Douglas River - Leeawn	IE_EA_09D020200	19/02/2019	Faith Wilson
Sample Number:	Location:	Stream Order:	Grid Reference:
GR4	Granamore Commonage - tributary stream of Douglas river	1 st order	S 99493 98934
Velocity:	Clarity:	Colour:	Discharge:
Torrential	Very clear	None	Flood
Fast	Clear	Slight	Normal
Moderate	Slightly turbid	Moderate	Low
Slow	Highly turbid	High	Very low
Very Slow			Dry
			Recent flood
Modifications: N	Dominant Types:	Slope:	Geology:
Canalised	Bedrock	Low	Calcareous
Widened	Boulder (>128mm)	Medium	Siliceous
Bank erosion	Cobble (32 - 128mm)	High	Mixed
Arterial drainage	Gravel (8 - 32mm)	Very high	
	Fine gravel (2 - 8mm)		
	Sand (0.25mm - 2mm)		
	Silt (<0.25mm)		
Substratum Condition:	Substratum:	Degree of Siltation:	Depth of Mud:
Compacted	Stoney bottom	Clean	None
Loose	Muddy bottom	Slight	<1cm
Normal	Mud over stones	Moderate	1-5cm
		Heavy	5-10cm
			>10cm
Litter:	Filamentous Algae:	Stream Flow:	Shading:

None	None	Riffle	High
Present	Present	Riffle/ glide	Moderate
Moderate	Moderate	Slow flow	Low
Abundant	Abundant		None
Stock Access:	Sewage Fungus:	Sample Type (Mins):	Main Land Use Adjacent/Upstream:
Yes - from the adjoining commonage	None	Kick sample - 3	Pasture
	Present	Stone washing	Bog
	Moderate	Weed sweep	Forestry
	Abundant		Tillage
			Urban
			Other - wet grassland/wet heath

Plate 1. Photographic record of sampling location - GR4.

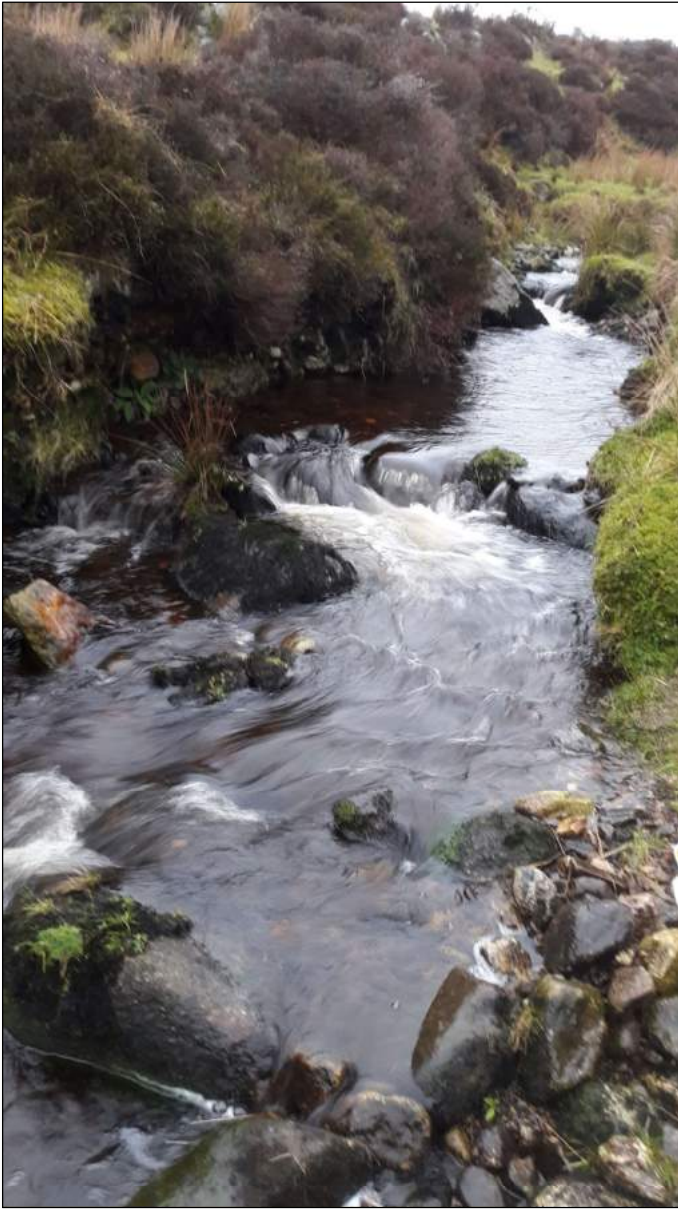
River:	Code:	Date:	Sample Taken By:
Douglas River - Roundhill Brook	IE_EA_09D020200	19/02/2019	Faith Wilson
Sample Number:	Location:	Stream Order:	Grid Reference:
GR5	Granamore Commonage - Roundhill Brook - Tributary stream of Douglas river	2 nd order	S 99339 99273
Velocity:	Clarity:	Colour:	Discharge:
Torrential	Very clear	None	Flood
Fast	Clear	Slight	Normal
Moderate	Slightly turbid	Moderate	Low
Slow	Highly turbid	High	Very low
Very Slow			Dry
			Recent flood
Modifications: N	Dominant Types:	Slope:	Geology:
Canalised	Bedrock	Low	Calcareous
Widened	Boulder (>128mm)	Medium	Siliceous
Bank erosion	Cobble (32 - 128mm)	High	Mixed
Arterial drainage	Gravel (8 - 32mm)	Very high	
	Fine gravel (2 - 8mm)		
	Sand (0.25mm - 2mm)		
	Silt (<0.25mm)		
Substratum Condition:	Substratum:	Degree of Siltation:	Depth of Mud:
Compacted	Stoney bottom	Clean	None
Loose	Muddy bottom	Slight	<1cm
Normal	Mud over stones	Moderate	1-5cm
		Heavy	5-10cm

>10cm
Litter:	Filamentous Algae:	Stream Flow:	Shading:
None	None	Riffle	High
Present	Present	Riffle/glide	Moderate
Moderate	Moderate	Slow flow	Low
Abundant	Abundant		None
Stock Access:	Sewage Fungus:	Sample Type (Mins):	Main Land Use Adjacent/Upstream:
Yes - from the adjoining commonage	None	Kick sample - 3	Pasture
	Present	Stone washing	Bog
	Moderate	Weed sweep	Forestry
	Abundant		Tillage
			Urban
			Other - wet grassland/wet heath

Plate 1. Photographic record of sampling location - GR5.

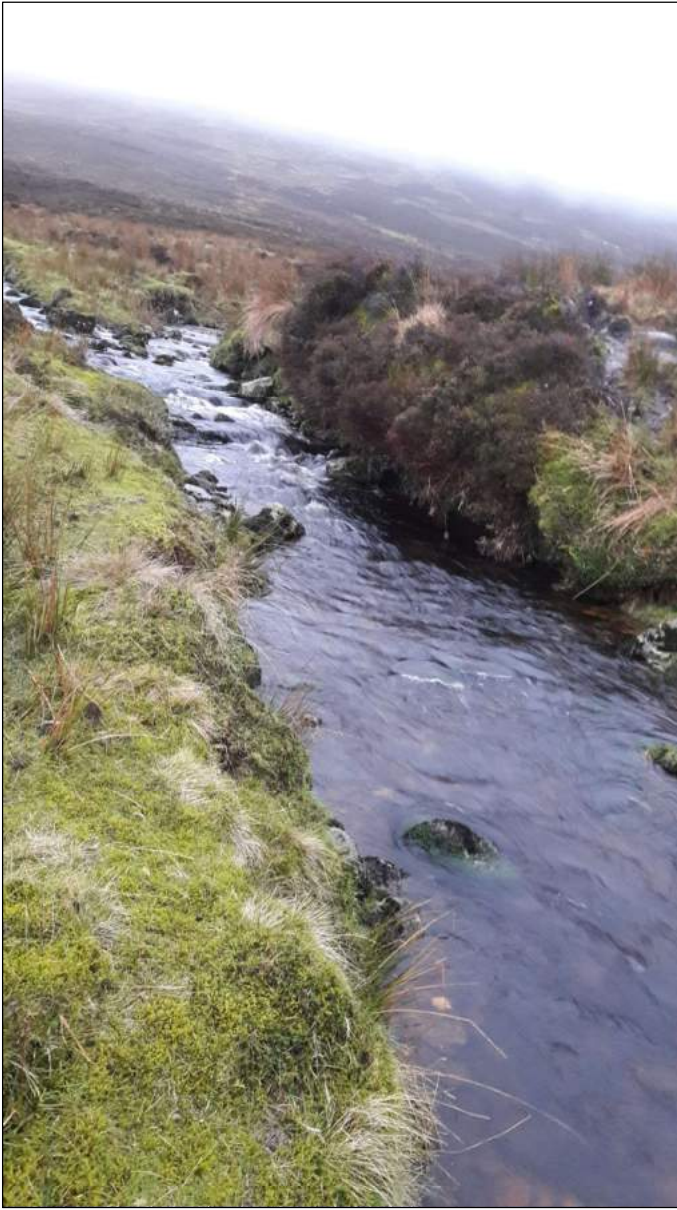
River:	Code:	Date:	Sample Taken By:
Douglas River	IE_EA_09D020200	19/02/2019	Faith Wilson
Sample Number:	Location:	Stream Order:	Grid Reference:
GR6	Granamore Commonage - below the confluence of Roundhill Brook and Douglas river	2 nd order	S 98603 99290
Velocity:	Clarity:	Colour:	Discharge:
Torrential	Very clear	None	Flood
Fast	Clear	Slight	Normal
Moderate	Slightly turbid	Moderate	Low
Slow	Highly turbid	High	Very low
Very Slow			Dry
			Recent flood
Modifications: N	Dominant Types:	Slope:	Geology:
Canalised	Bedrock	Low	Calcareous
Widened	Boulder (>128mm)	Medium	Siliceous
Bank erosion	Cobble (32 - 128mm)	High	Mixed
Arterial drainage	Gravel (8 - 32mm)	Very high	
	Fine gravel (2 - 8mm)		
	Sand (0.25mm - 2mm)		
	Silt (<0.25mm)		
Substratum Condition:	Substratum:	Degree of Siltation:	Depth of Mud:
Compacted	Stoney bottom	Clean	None
Loose	Muddy bottom	Slight	<1cm
Normal	Mud over stones	Moderate	1-5cm
		Heavy	5-10cm
			>10cm

Litter:	Filamentous Algae:	Stream Flow:	Shading:
None	None	Riffle	High
Present	Present	Riffle/ glide	Moderate
Moderate	Moderate	Slow flow	Low
Abundant	Abundant		None
Stock Access:	Sewage Fungus:	Sample Type (Mins):	Main Land Use Adjacent/Upstream:
Yes - from the adjoining commonage	None	Kick sample - 3	Pasture
	Present	Stone washing	Bog
	Moderate	Weed sweep	Forestry - recent clearfell
	Abundant		Tillage
			Urban
			Other - wet grassland/wet heath

Plate 1. Photographic record of sampling location - GR6.

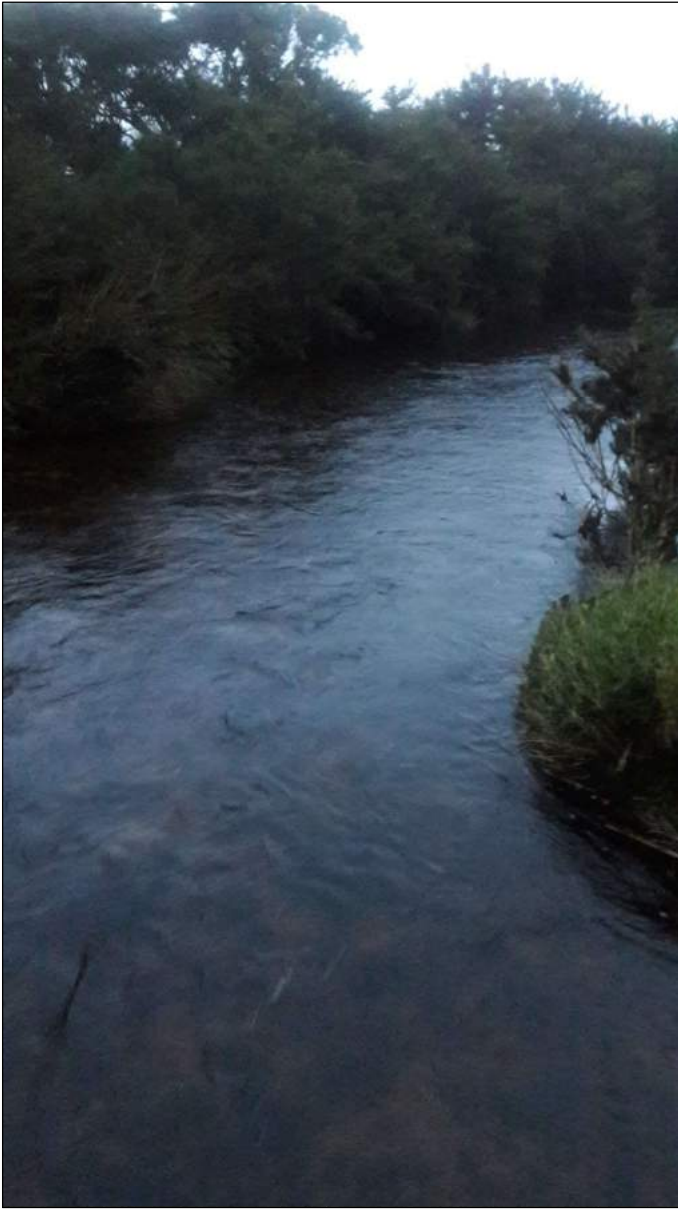
River:	Code:	Date:	Sample Taken By:
Douglas River	IE_EA_09D020200	19/02/2019	Faith Wilson
Sample Number:	Location:	Stream Order:	Grid Reference:
GR7	Granamore Commonage – Douglas River - below the ford at Cordoo/Corragh	2 nd order	S 98265 00112
Velocity:	Clarity:	Colour:	Discharge:
Torrential	Very clear	None	Flood
Fast	Clear	Slight	Normal
Moderate	Slightly turbid	Moderate	Low
Slow	Highly turbid	High	Very low
Very Slow			Dry
			Recent flood
Modifications: Y	Dominant Types:	Slope:	Geology:
Canalised	Bedrock	Low	Calcareous
Widened	Boulder (>128mm)	Medium	Siliceous
Bank erosion	Cobble (32 - 128mm)	High	Mixed
Arterial drainage	Gravel (8 - 32mm)	Very high	
Stone ford created upstream	Fine gravel (2 - 8mm)		
	Sand (0.25mm - 2mm)		
	Silt (<0.25mm)		
Substratum Condition:	Substratum:	Degree of Siltation:	Depth of Mud:
Compacted	Stoney bottom	Clean	None
Loose	Muddy bottom	Slight	<1cm
Normal	Mud over stones	Moderate	1-5cm

Heavy	5-10cm
			>10cm
Litter:	Filamentous Algae:	Stream Flow:	Shading:
None	None	Riffle	High
Present	Present	Riffle/ glide	Moderate
Moderate	Moderate	Slow flow	Low
Abundant	Abundant		None
Stock Access:	Sewage Fungus:	Sample Type (Mins):	Main Land Use Adjacent/Upstream:
Yes - from the adjoining commonage	None	Kick sample - 3	Pasture
	Present	Stone washing	Bog
	Moderate	Weed sweep	Forestry – recent clearfell
	Abundant		Tillage
			Urban
			Other – wet grassland/wet heath

Plate 1. Photographic record of sampling location - GR7.
